# **Australia & New Zealand Operation & Maintenance Guide**

# Use of this Operation & Maintenance Guide

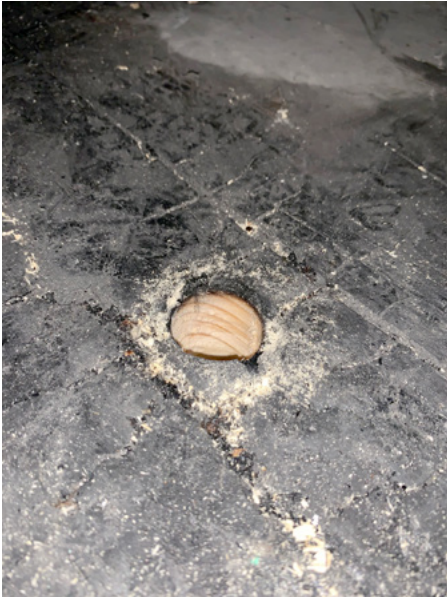
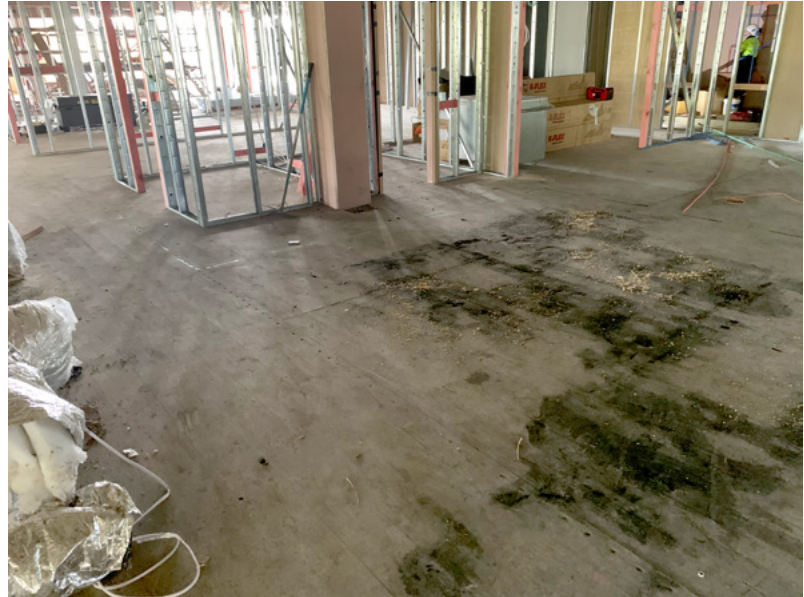
**Event** A fire occurred during the construction phase leading to damage as per these photos.

Damaged Floor Panels

- Assessment of damage by a certified engineer.
- Determination of repairs required by a certified engineer.
- Engineer certified proposed repairs will meet fire and structural requirements of the building.
- Contractor appointed to carry out repairs.
- Measurement of areas to be repaired for manufacture of replacement CLT panels and other building elements including steel members.
- SWMS completed.
- Materials and equipment ordered including any additional PPE and site safety equipment to carry out repairs.
- Damaged panels removed as per plan.
- Steel members replaced as per plan.
- Replacement of damaged panels and steel members as per plan.
- Final inspection and sign off by engineer.

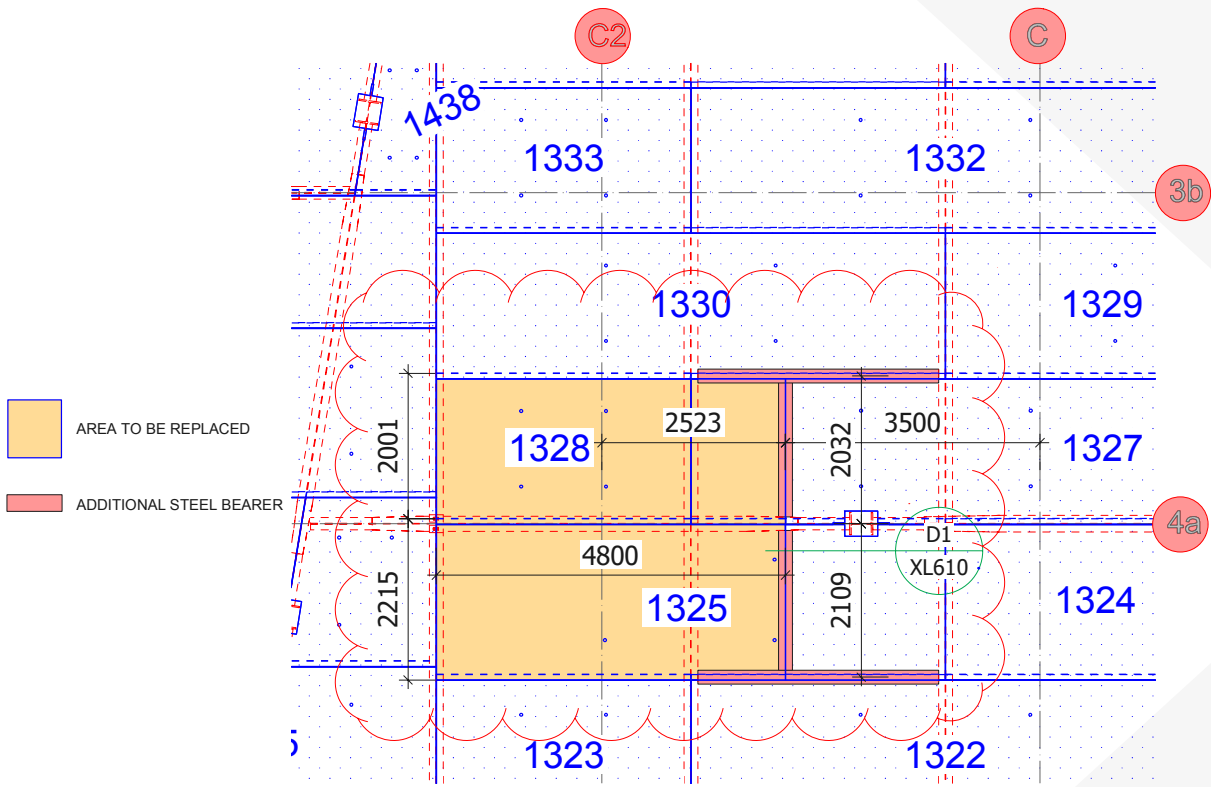
Measurement of area to be repaired

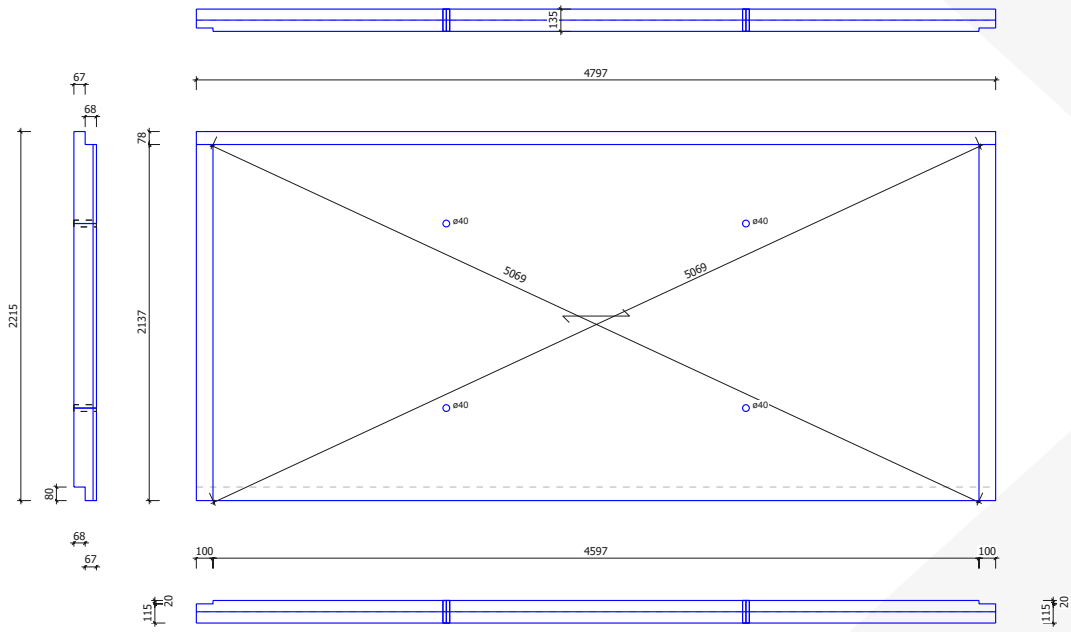
Drawing of replacement panel

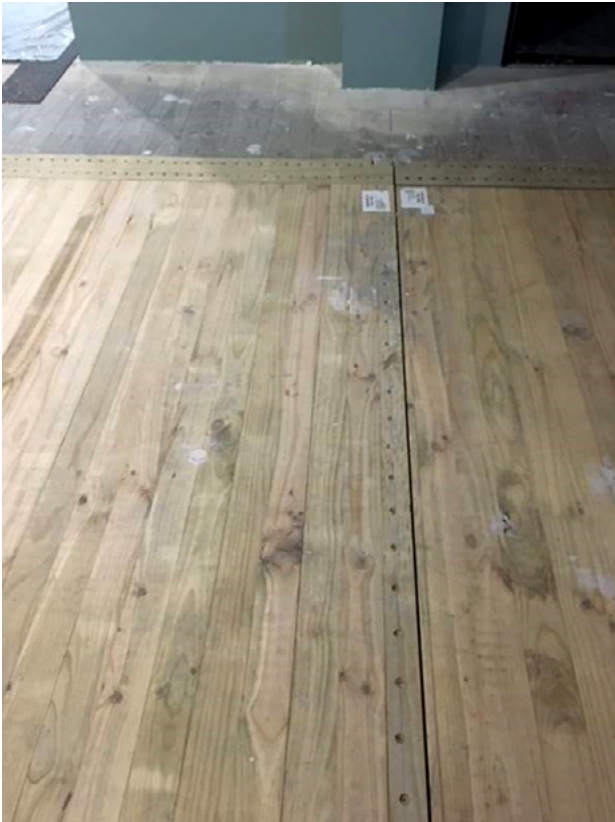
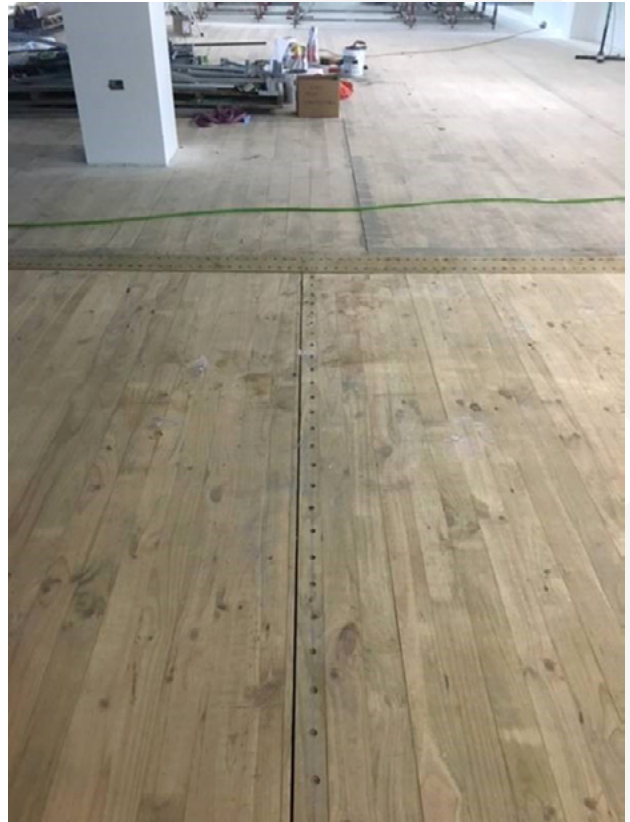
Repaired Floor Panels

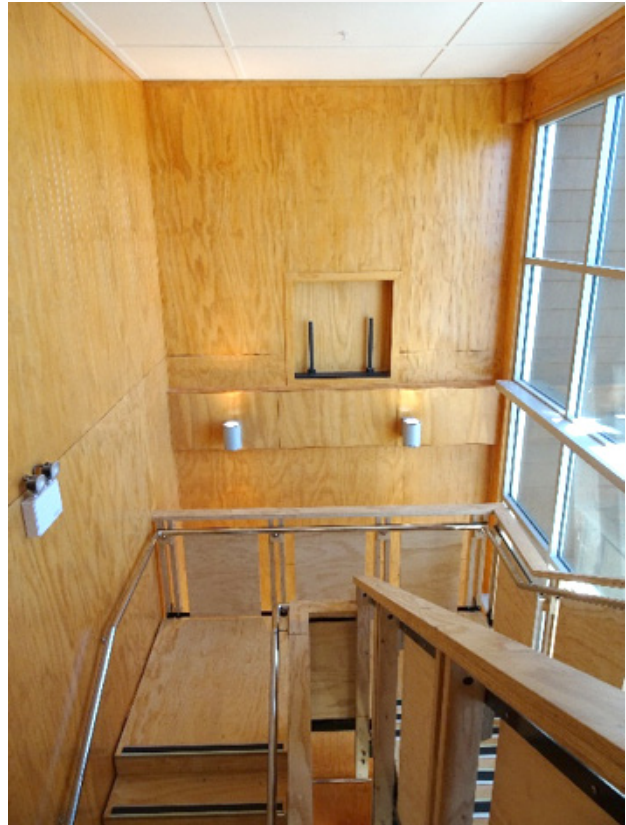
very little sign of damage, other than slight cosmetic cracking to the pavement and some movement at the joints between elements. There was no sign of the walls rocking, or yielding of the dissipater bars. This suggests the building has capacity to withstand an event even larger than that experienced in the early morning of 14th November.

Rocking shear walls show little sign of damage
